X-ray Inspection System for Package Check

XR75
Packing Check

Introducing the XR75 Packing Check specialized for package integrity checks.

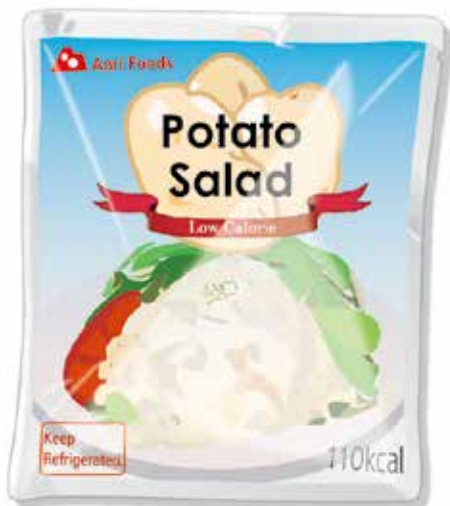
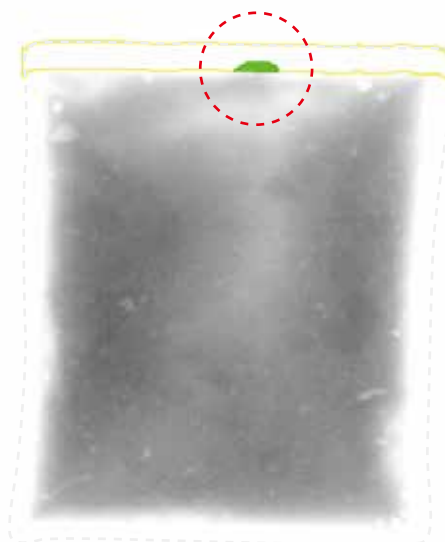
Inspection of potato salad in a pouch.

The seal area that contains product absorbs more X-rays than the normal seal area.

The XR75 Packing Check is specially designed for detecting seal defects in food packages. X-ray absorption rate can vary depending on the thickness of the seal area on the package. The Packing Check generates the alarm when detecting defects in the seal area by measuring the difference in x-ray absorption between the normal and the defective seal areas. Wrinkles on the seal area can be identified on the same principle.

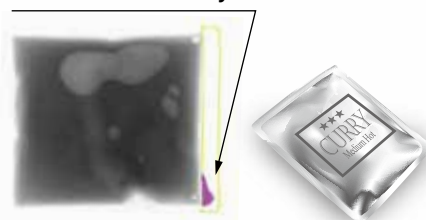
Product caught in the seal area absorbs more X-rays

X-ray transmission image of retort pouch curry

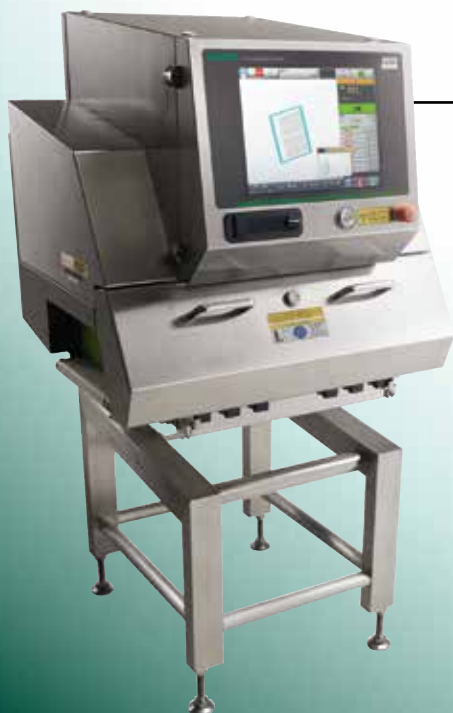
[Major inspection functions]

Contaminant Detection, Shape Detection, Count Detection, Virtual Weight Check, Package Check

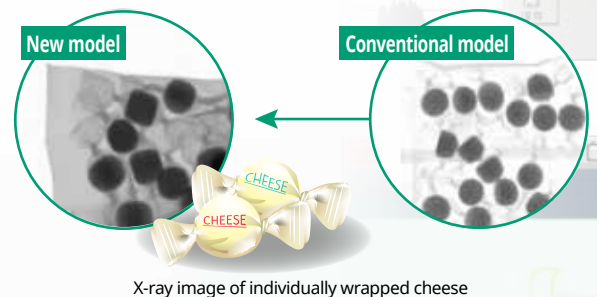
The Packing Check is equipped with the new x-ray sensor developed in-house using our years of experience. This new sensor enables the system to accurately identify the seal area of various types of packaging. The XR75 Packing Check helps achieve the highest product quality by detecting a small amount of the product caught in the seal area, which is hardly identified by visual inspection.

X-ray image of individually wrapped cheese

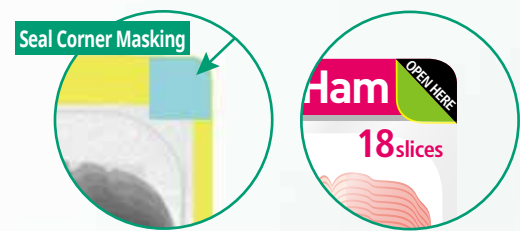
Advanced masking function minimizes false rejects around the opening point

Deformation such as wrinkles and curl on the seal corner of vacuum packs or trays can trigger false rejects during the inspection of sealing integrity by conventional inspection systems. The Seal Corner Masking enables the system to maintain the optimum inspection performance, reducing the possibility of false rejection on the deformed seal corner.

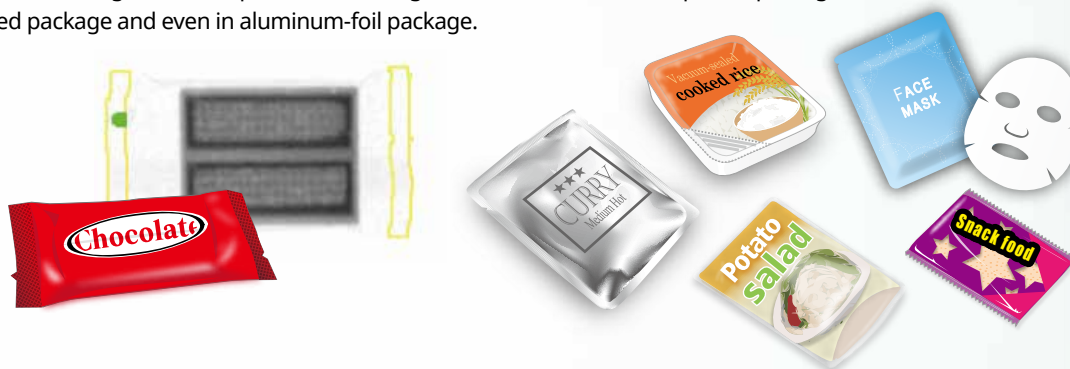
Detect contaminants in colored packages

It is difficult for cameras for vision systems to capture contaminants in colored packages. The XR75 Packing Check is capable of detecting seal defects in semi-transparent package, colored package and even in aluminum-foil package.

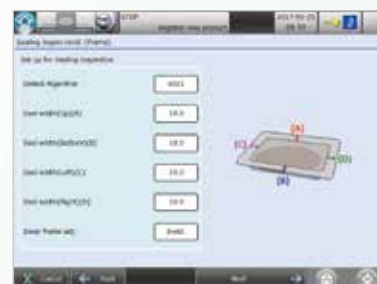
- Product Registration Navigation simplifies setting procedures with step-by-step illustrated instructions.
- Setting procedures for package check are simplified.

Packaging material is recognized by simply entering the seal width. The optimal inspection settings are automatically determined without the complicated adjustment.

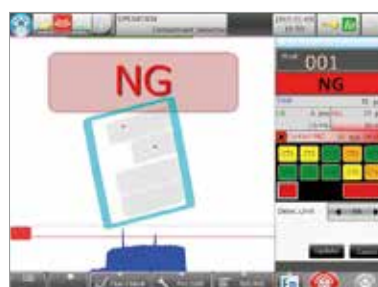
[Easy to adjust sensitivity]

Detection levels are visually shown on the main screen to enhance usability. Quick sensitivity adjustments are possible (based on operator level).

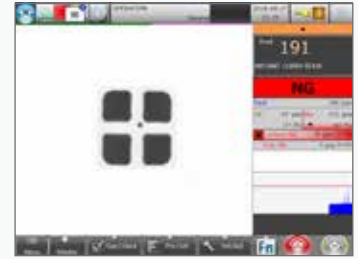
Instant curry roux

Examples of product caught in the seal area

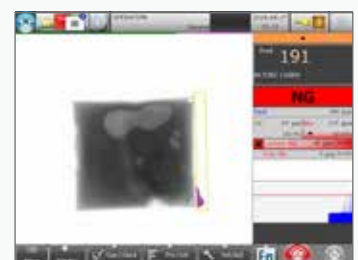
Retort pouch curry

The X-ray system may not be able to detect product caught in the seal area depending on the amount of product trapped within the sealing area, type and thickness of package, and filling amount of contents.

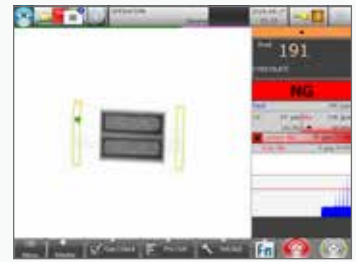
Individually wrapped chocolate

Examples of product caught in the seal area

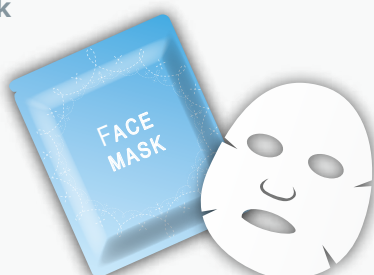
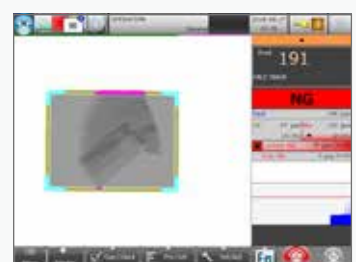
Face mask

The X-ray system may not be able to detect product caught in the seal area depending on the amount of product trapped within the sealing area, type and thickness of package, and filling amount of contents.

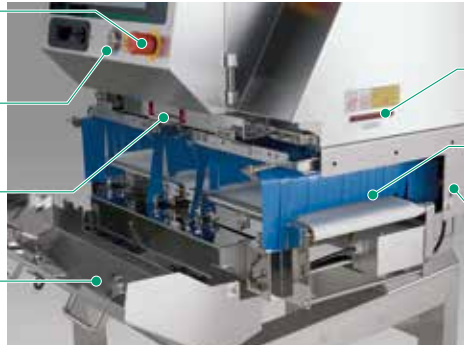
Anritsu safety mechanism

Emergency stop switch

Cuts power to x-ray and drive circuits, stops the conveyor and x-ray radiation

X-ray ON/OFF key

Turning the key to OFF stops x-ray radiation completely

X-ray shield cover open/close sensor

Opening the cover stops x-ray radiation completely

X-ray shield cover

Opened/Closed using x-ray irradiation ON/OFF key. Opening the cover stops x-ray radiation due to the x-ray shield cover open/close sensor

X-ray irradiation display

The lamp is lit during x-ray radiation

Leakage prevention curtain

Prevents x-ray leakage

Hand insertion sensor

Interrupting the sensor for a certain period of time stops x-ray radiation
